REHABILITATION OF CADANGAN MEMBINA DUA (2) BLOK PANGSAPURI KOS TINGGI (RP) 15 TINGKAT (SEJUMLAH 360 UNIT) DENGAN 2 TINGKAT PODIUM, 1 BLOK TEMPAT LETAK KERETA DAN 2 UNIT PENCAWANG ELEKTRIK SERTA KEMUDAHAN KOLAM RENANG DI ATAS SEBAHAGIAN TANAH KERAJAAN, OFF JALAN KUARI, CHERAS BARU, MUKIM AMPANG, DAERAH HULU LANGAT, SELANGOR DARUL EHSAN BAGI MUDI ANGKASA DEVELOPMENT SDN. BHD. (IN LIQUIDATION)

Work Progress as of 29th May 2013

Schedule Progress : 99.67%
 Actual Progress : 88.46%
 Variance : 11.21%

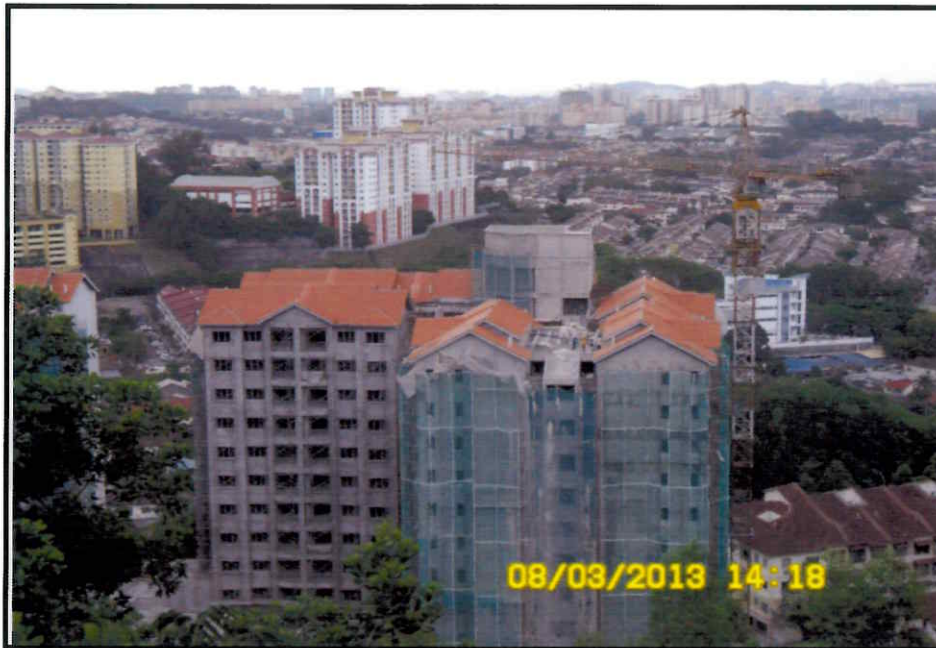
External view for Block A as of 14/03/13

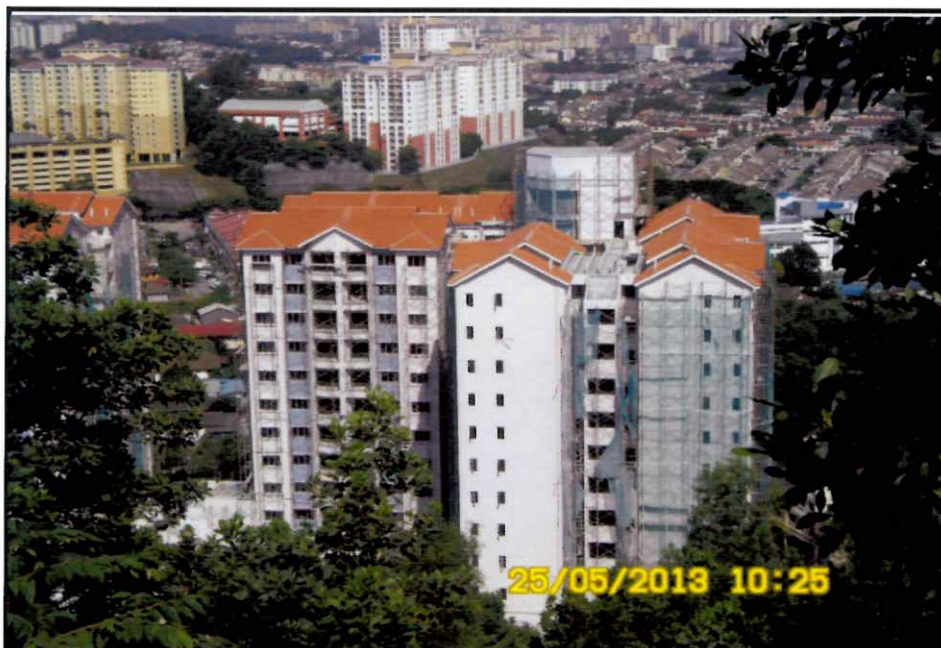
External view for Block A as of 29/05/13

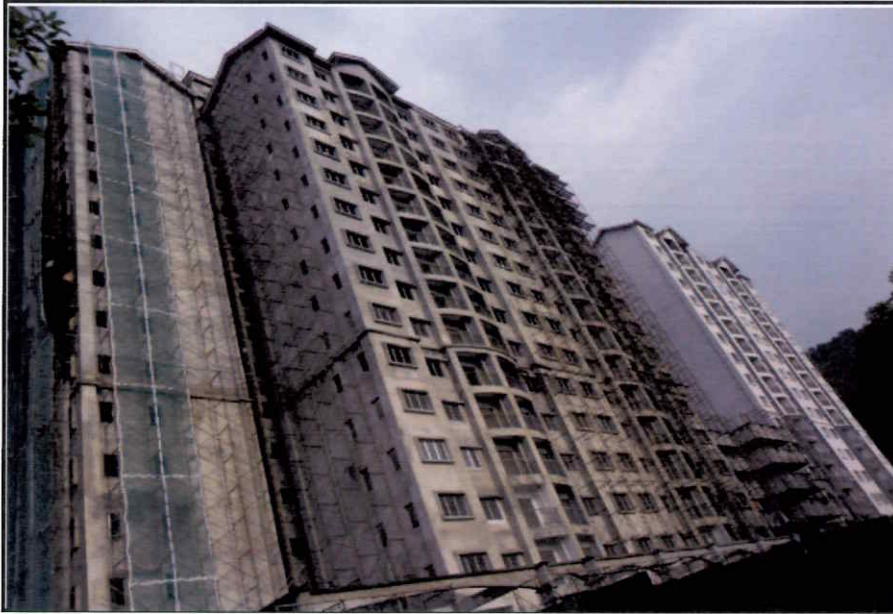
External view for Block A & B as of 14/03/13

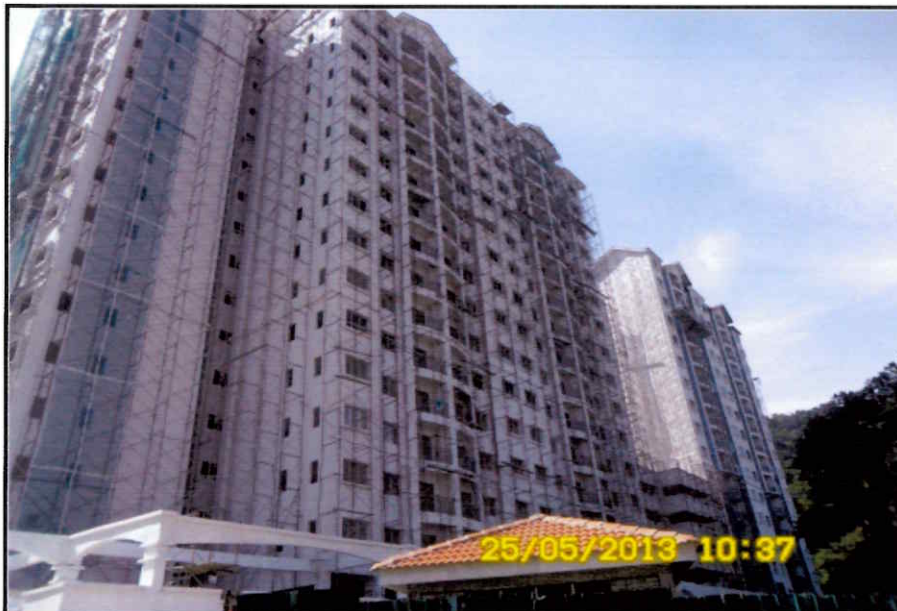
External view for Block A & B as of 29/05/13

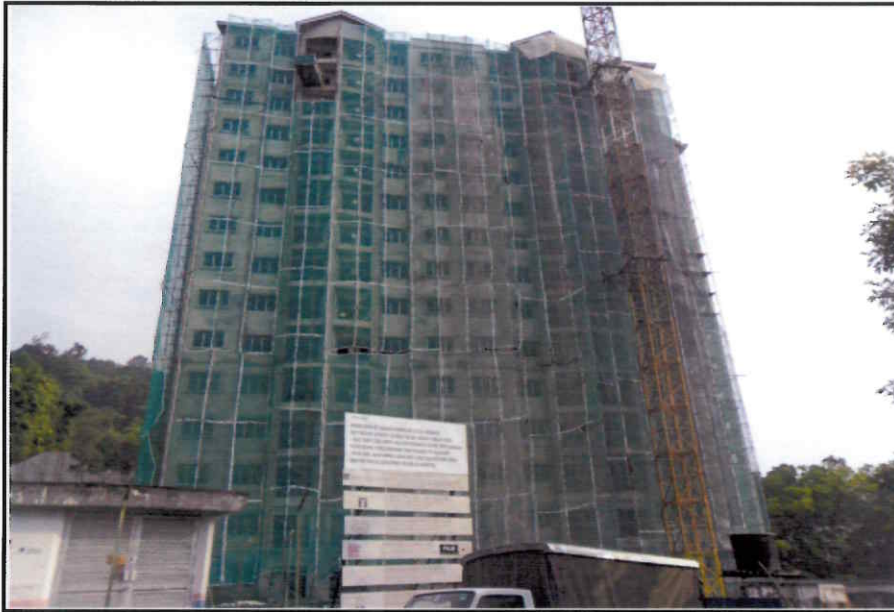
External front view of Block A as of 14/03/13

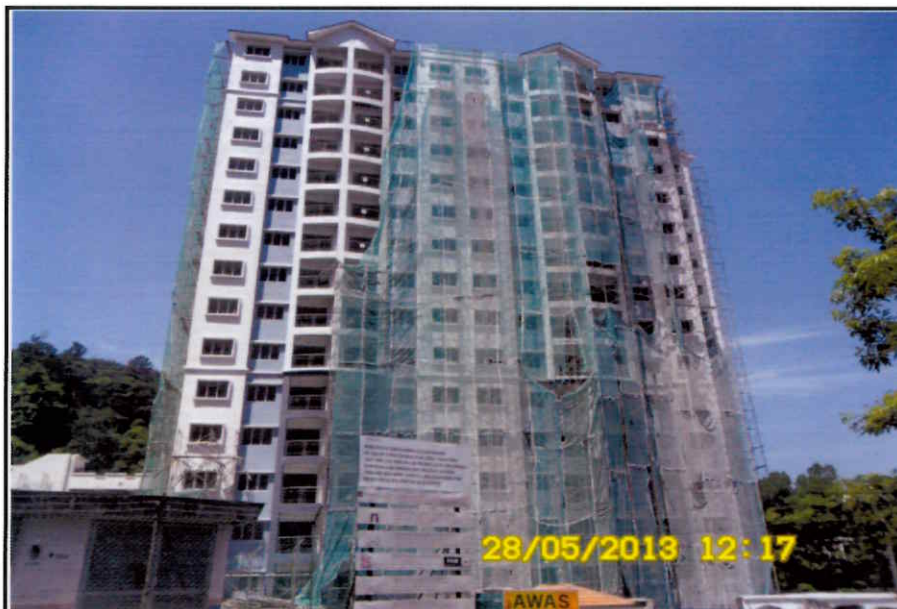
External front view of Block A as of 29/05/13

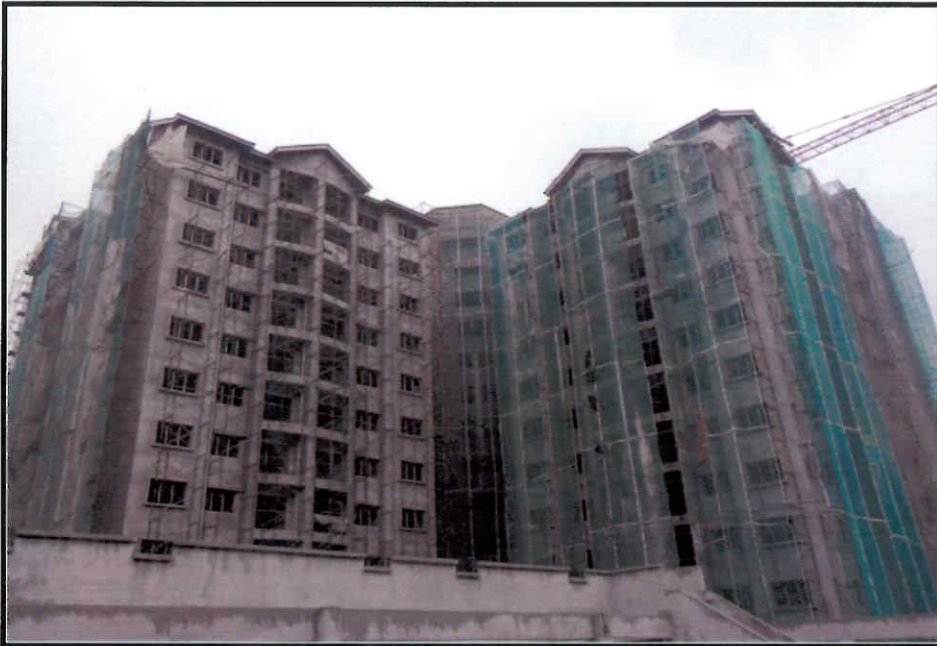
External elevation view of Block A as of 14/03/13

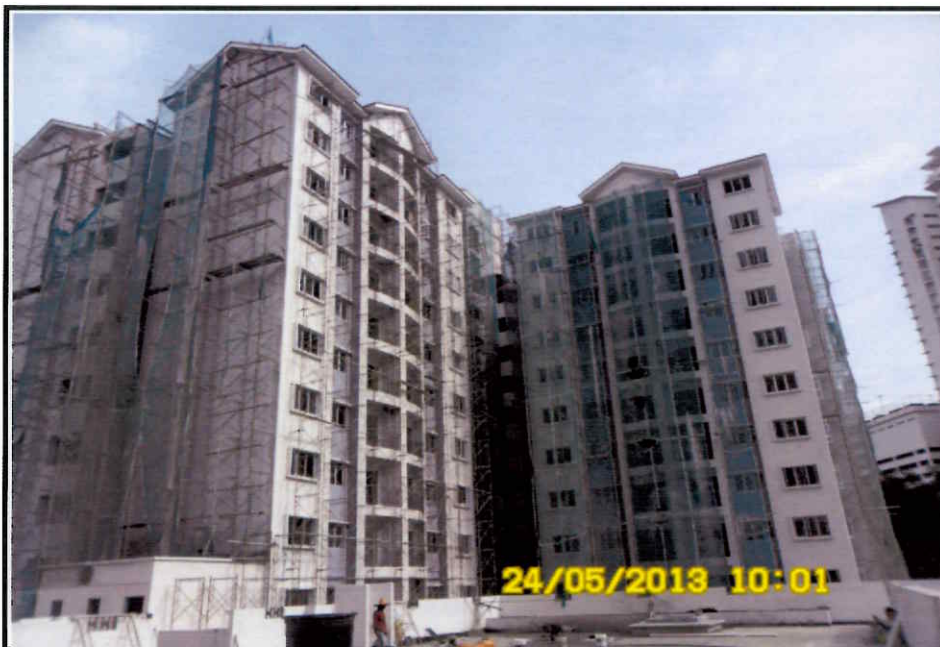
External elevation view of Block A as of 29/05/13

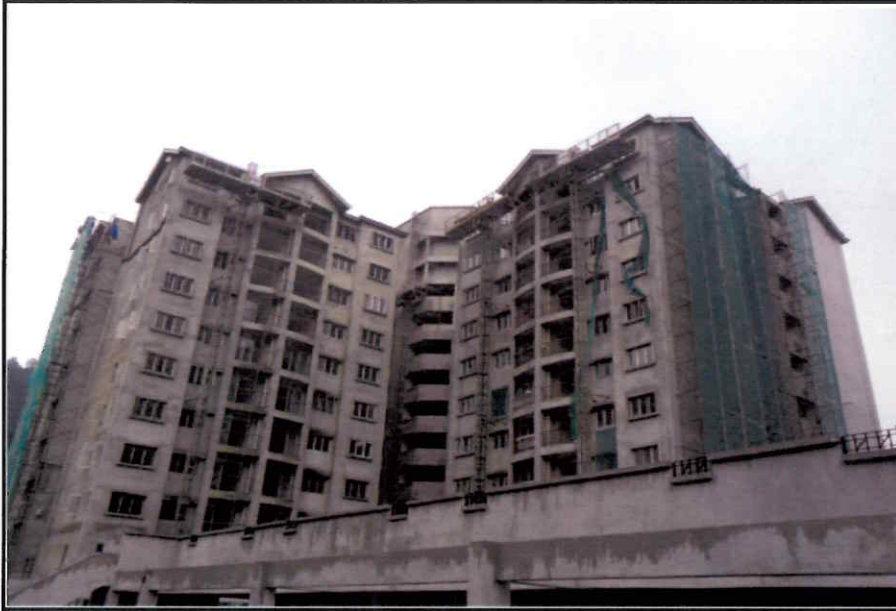
External elevation view of Block B as of 14/03/13

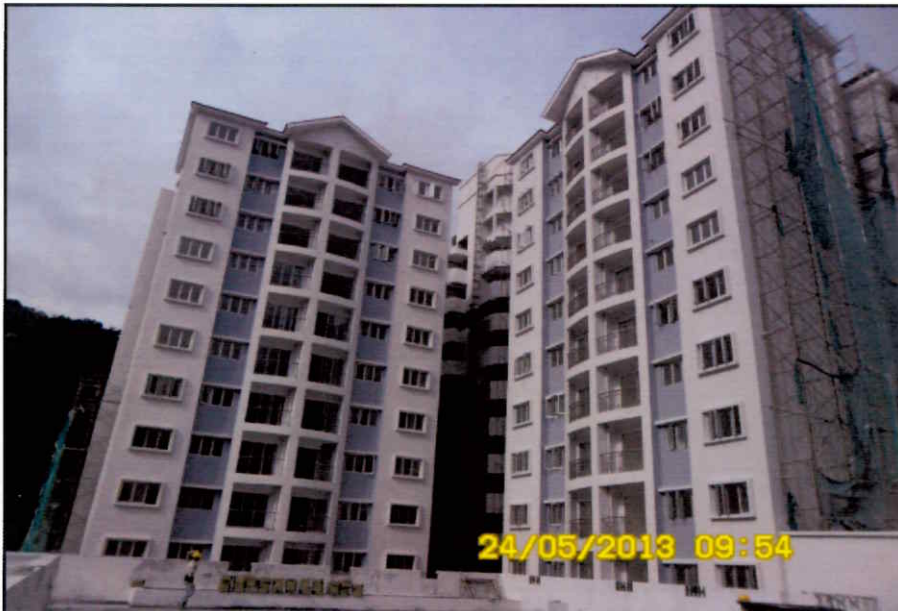
External elevation view of Block B as of 29/05/13

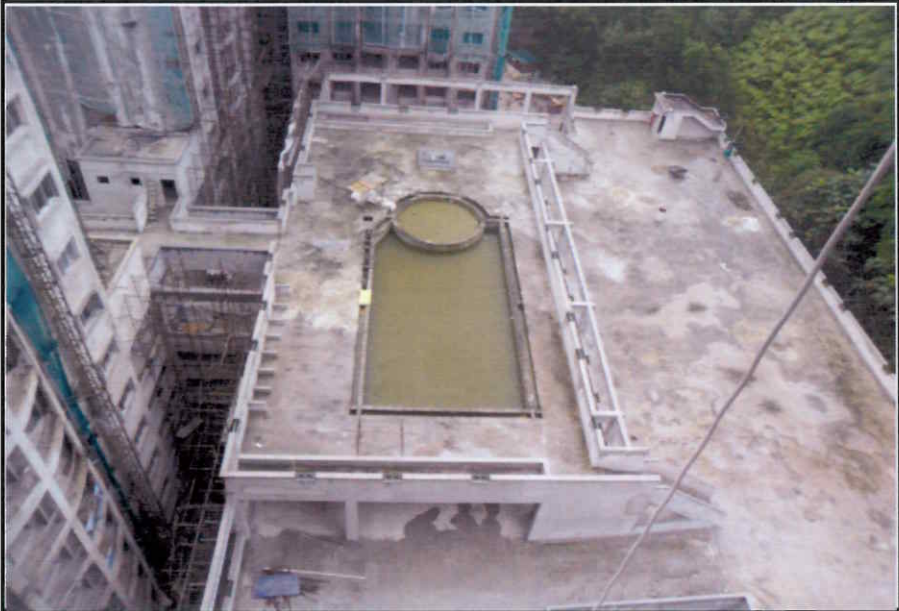
External view of swimming pool as of 14/03/13

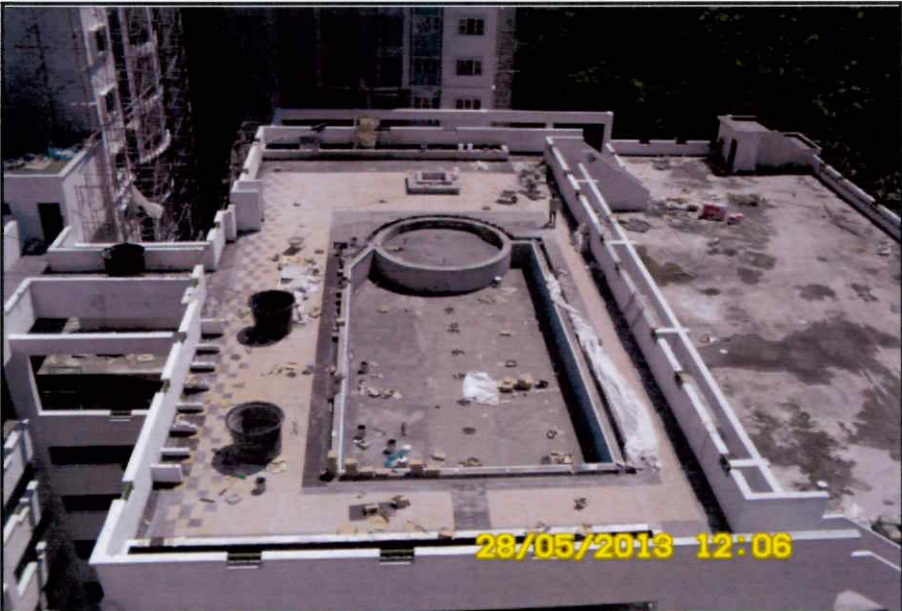
External view of swimming pool as of 29/05/13
